# **INDOOR AIR QUALITY ASSESSMENT**

**Helen R. Donaghue Elementary School  
24 Union Street Extension  
Merrimac, Massachusetts**

Prepared by:  
Massachusetts Department of Public Health  
Bureau of Environmental Health Assessment  
Emergency Response/Indoor Air Quality Program  
August 2003

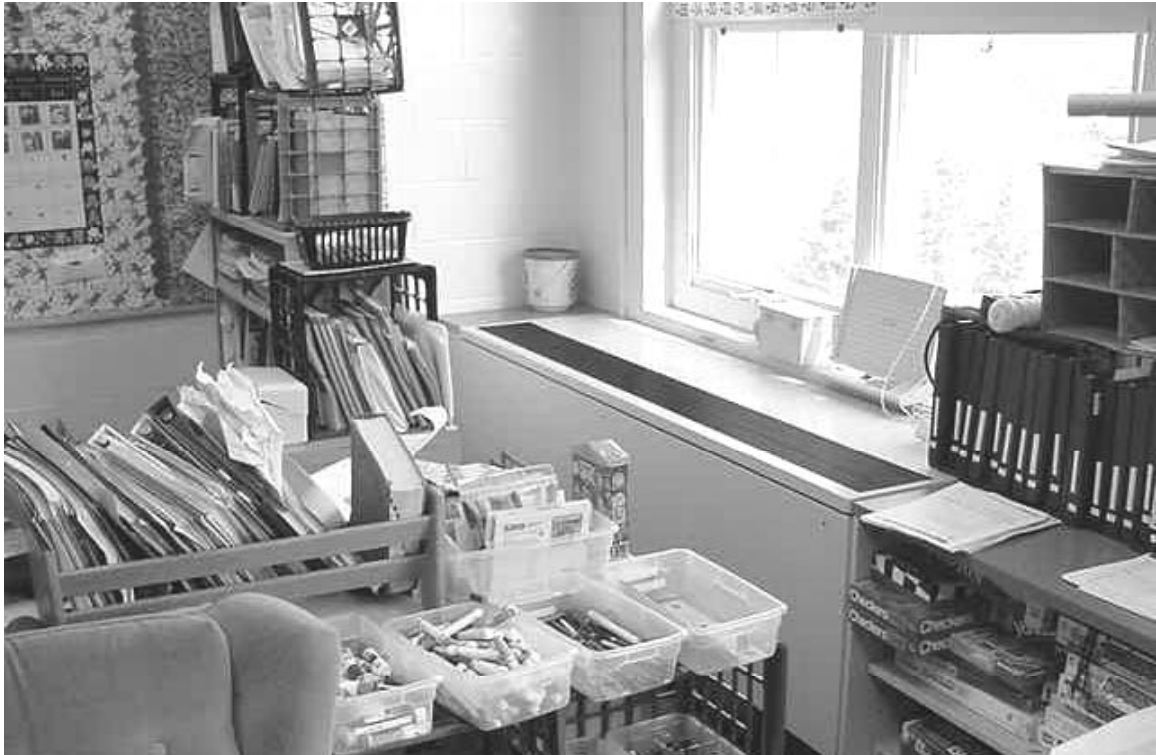
**Picture 1**

Fresh air in classrooms is supplied by a unit ventilator (univent) system. Univents draw air from outdoors through a fresh air intake located on the exterior walls of the building and return air through an air intake located at the base of each unit ([Figure 1](#)). Fresh and return air are mixed, filtered, heated and provided to classrooms through a fresh air diffuser located in the top of the unit. Univents have three controls: low, high and off. Univents were deactivated or providing weak airflow in many classrooms throughout the school. Obstructions to airflow, such as furniture located in front of univents or materials stored on univents, were also observed in a number of classrooms

(Picture 1). In order for univents to provide fresh air as designed, these units must remain “on” and allowed to operate while rooms are occupied. In addition, intakes must remain free of obstructions.

Also of note was the amount of materials stored inside classrooms (Picture 1). In classrooms throughout the school, items were seen piled on windowsills, tabletops, counters, bookcases and desks. The large amount of items stored in classrooms provides

**Plant and paper goods stored in front of univent return vent**

3. Inspect exhaust motors and belts for proper function, repair and replace as necessary.
4. Remove all blockages from univents and exhaust vents.
5. Consider having ventilation systems re-balanced every five years by an HVAC engineering firm.

12. Store cleaning products properly and out of reach of students. Store flammables in a flameproof cabinet.
13. Relocate or consider reducing the amount of materials stored in classrooms to allow for more thorough cleaning. Clean items regularly with a wet cloth or sponge to prevent excessive dust build-up.

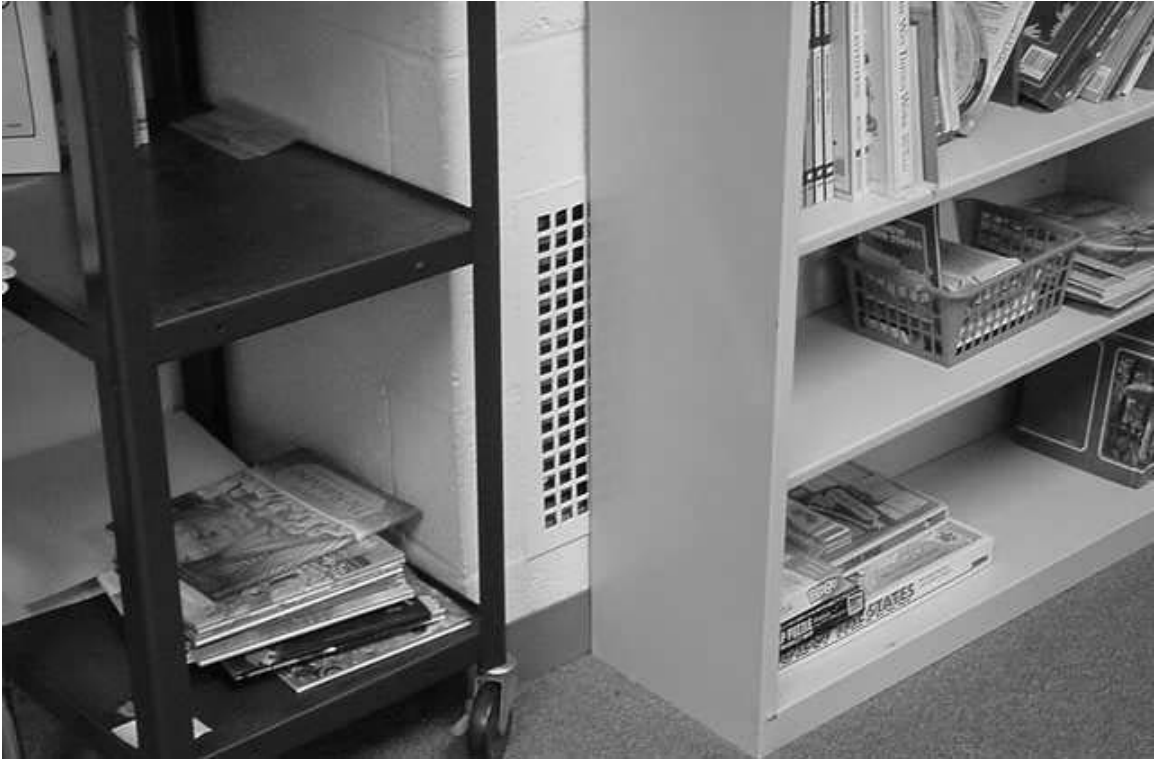
**Picture 2**

**Wall-mounted exhaust vent blocked by bookcase**

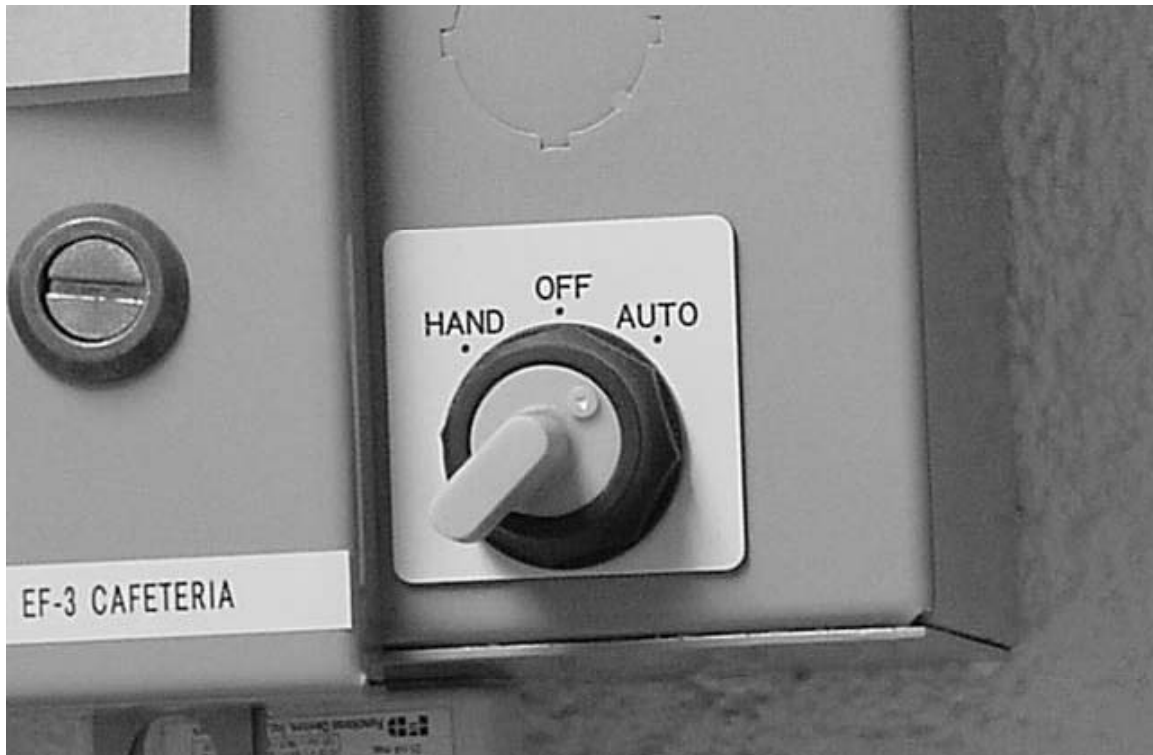
**Picture 3**

Mechanical ventilation in the gymnasium and cafeteria is provided by ceiling-mounted air handling units (AHUs) activated from a control panel. Units were set to the “auto” setting (Picture 3). The automatic setting on the control panel activates the AHUs at a preset temperature. Once a preset temperature is measured by the thermostat, the HVAC system is deactivated. Therefore no mechanical ventilation is provided until the thermostat re-activates the system.

**AHU set to 'automatic'**

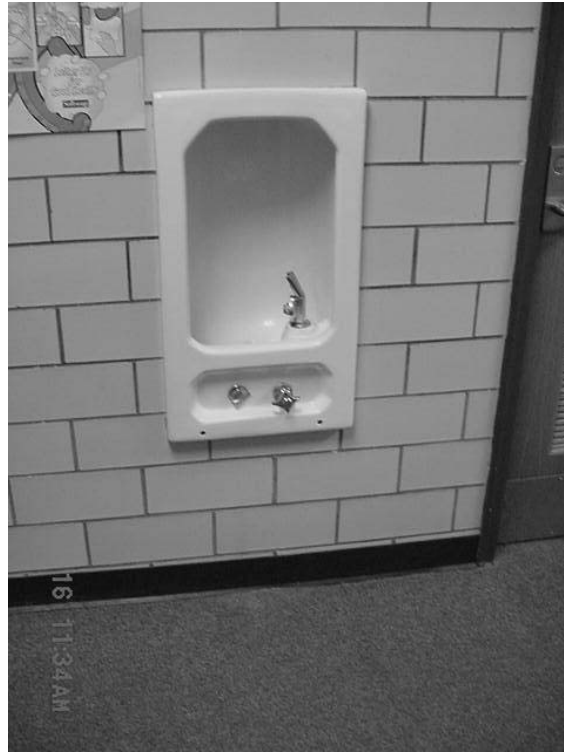
**Picture 4**

A number of conditions conducive to microbial growth were noted at the DES. A water fountain is located in a carpeted hallway outside the custodian's office (Picture 4). Carpeting directly beneath the fountain is water damaged. To avoid water damage to

**Water damage to carpeting**

carpeting and/or prevent potential mold growth, a water-resistant material such as plastic or rubber matting should be installed beneath water fountains and/or water coolers. The American Conference of Governmental Industrial Hygienists (ACGIH) recommends that carpeting be dried with fans and heating within 24 hours of becoming wet (ACGIH, 1989). If carpets are not dried within this time frame, mold growth may occur. Water-damaged carpeting cannot be adequately cleaned to remove mold growth. The application of a mildewcide to moldy carpeting is not recommended.

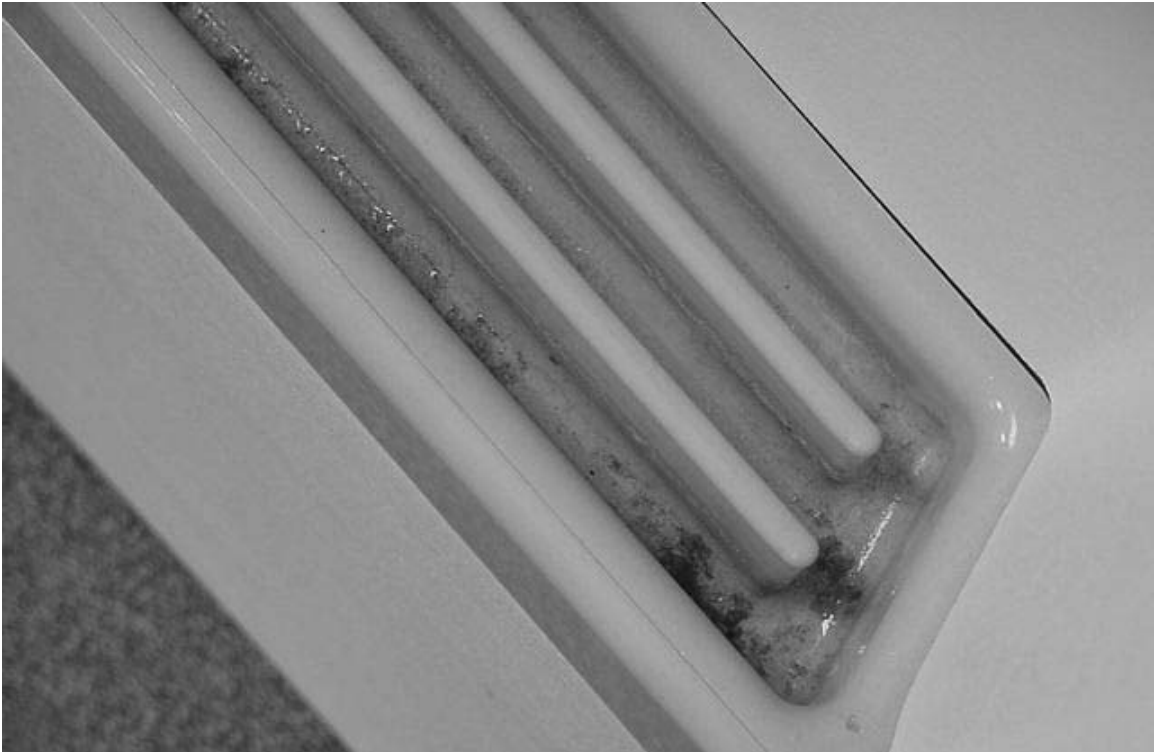
**Picture 5**

Water coolers are located in lounge areas. Standing water and debris were noted in catch basins (Picture 5). Stagnant water can provide a medium for bacterial and microbial growth. To prevent growth, catch basins should be emptied and cleaned regularly.

**Standing water in bubbler catch basin, dark stains indicate accumulated debris/microbial growth**

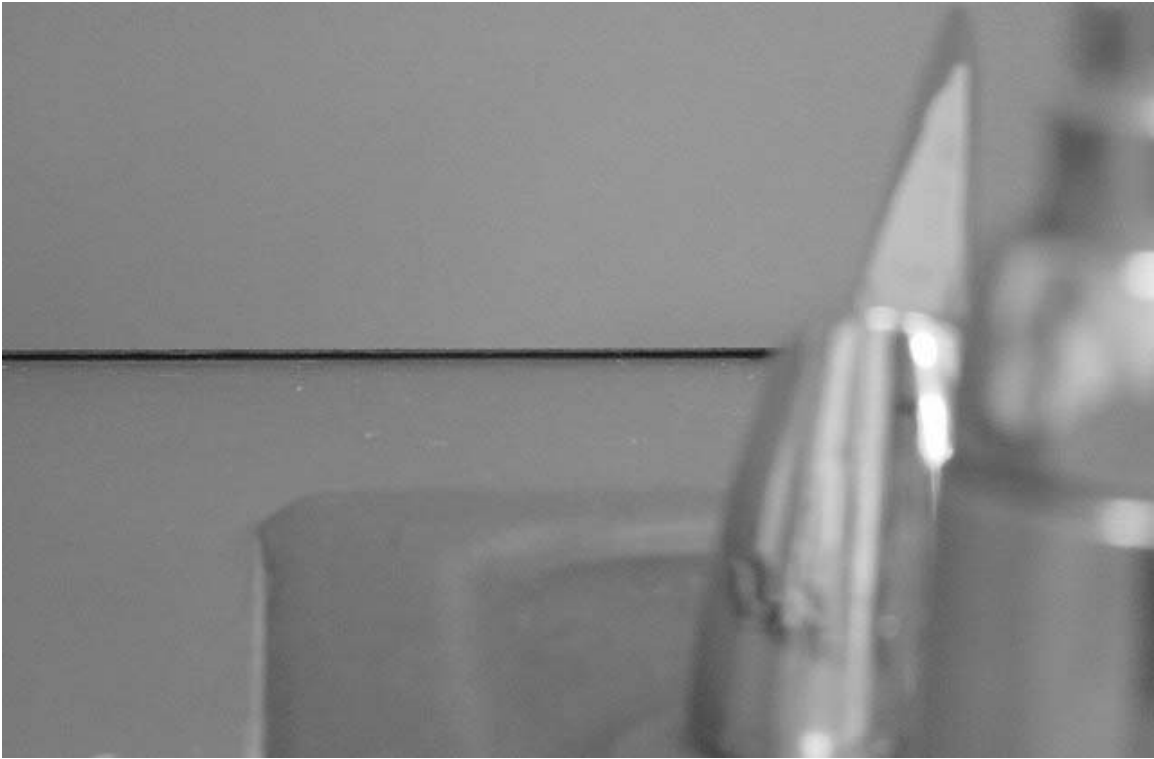
**Picture 6**

In a number of classrooms, spaces between the sink countertop and backsplash were noted (Picture 6). Improper drainage or sink overflow could lead to water penetration. If the seam is not watertight, water can penetrate the and collect behind the countertop or cabinets or in cabinets. Like other porous materials, if these materials become wet repeatedly they can provide a medium for mold growth.

**Breach between countertop and splashboard in sink area**

11. Seal areas around sinks to prevent water-damage to the interior of cabinets and adjacent wallboard. Inspect wallboard for water-damage and mold/mildew growth, repair/replace as necessary. Disinfect areas with an appropriate antimicrobial, as needed.

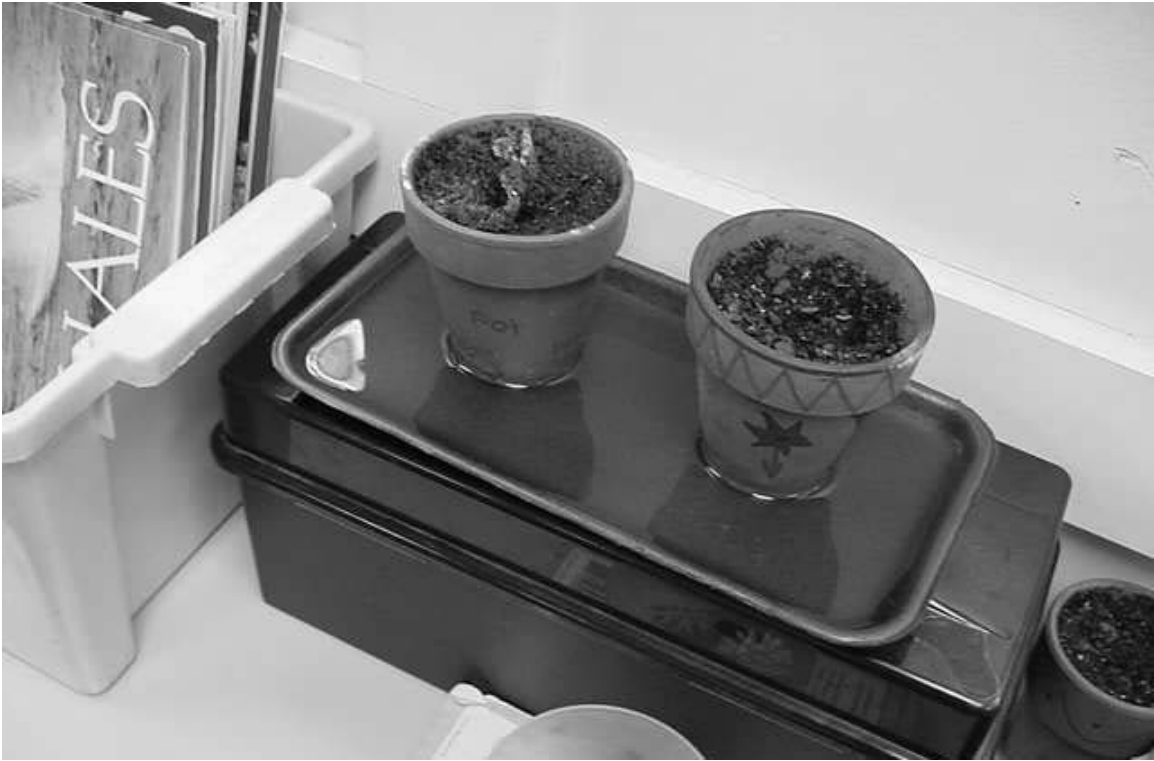
**Picture 7**

Several classrooms contained a number of plants. Some plants were noted in standing water (Picture 7). In several classrooms, plants were found on top of univents. Containers with potting soil (no plants) were found in room 11. Plants, soil and drip pans can serve as sources of mold growth, thus should be properly maintained. Plants should have drip pans to prevent wetting and subsequent mold colonization of window frames. Over-watering of plants should be avoided, and drip pans should be inspected

**Plants and standing water**

periodically for mold growth. Plants should also be located away from univents and ventilation sources to prevent aerosolization of dirt, pollen or mold.

8. Move plants away from univents in classrooms. Ensure all plants are equipped with drip pans. Examine drip pans for mold growth and disinfect areas of water leaks with an appropriate antimicrobial where necessary. Consider reducing the number of plants.

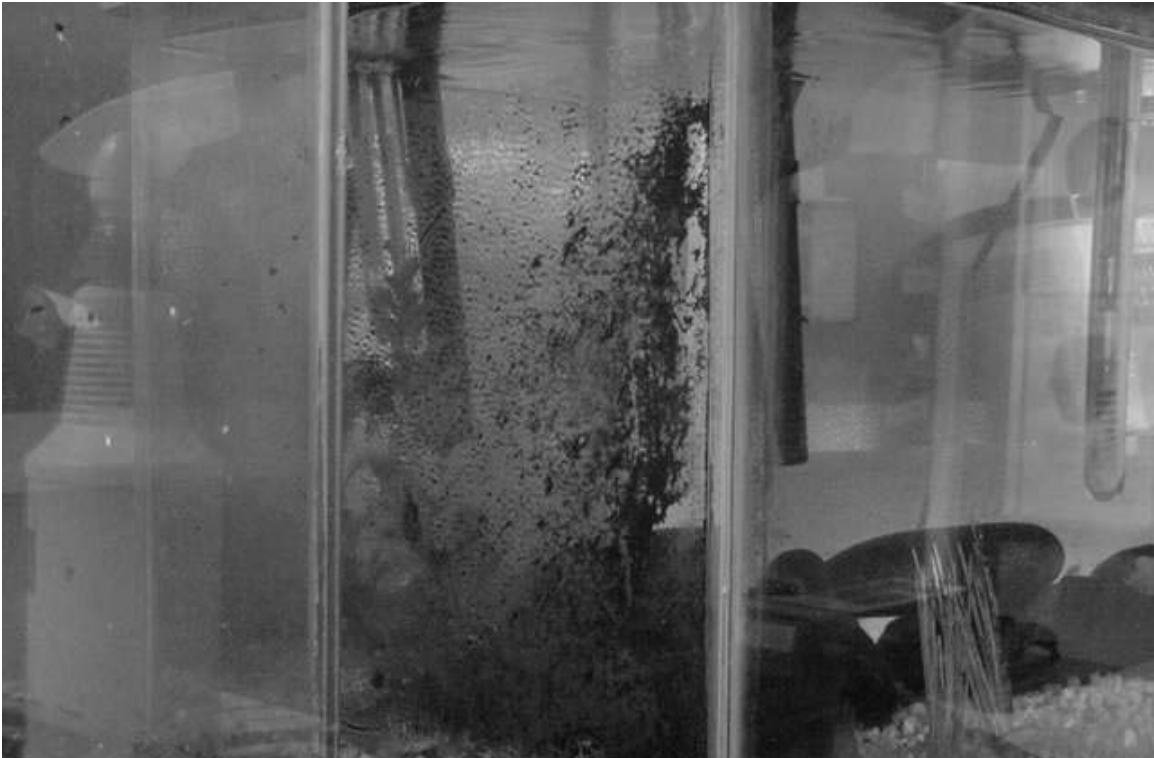
**Picture 8**

Several rooms contained aquariums and terrariums (Table 1). Some aquariums and terrariums had mold or algae growing on the glass surface (Picture 8). Room 20 contained an aquarium with a decaying fish body floating at the surface (Picture 9). Aquariums and terrariums should be properly maintained and cleaned to prevent bacterial growth, mold growth and nuisance odors.

**Algal growth in aquarium**

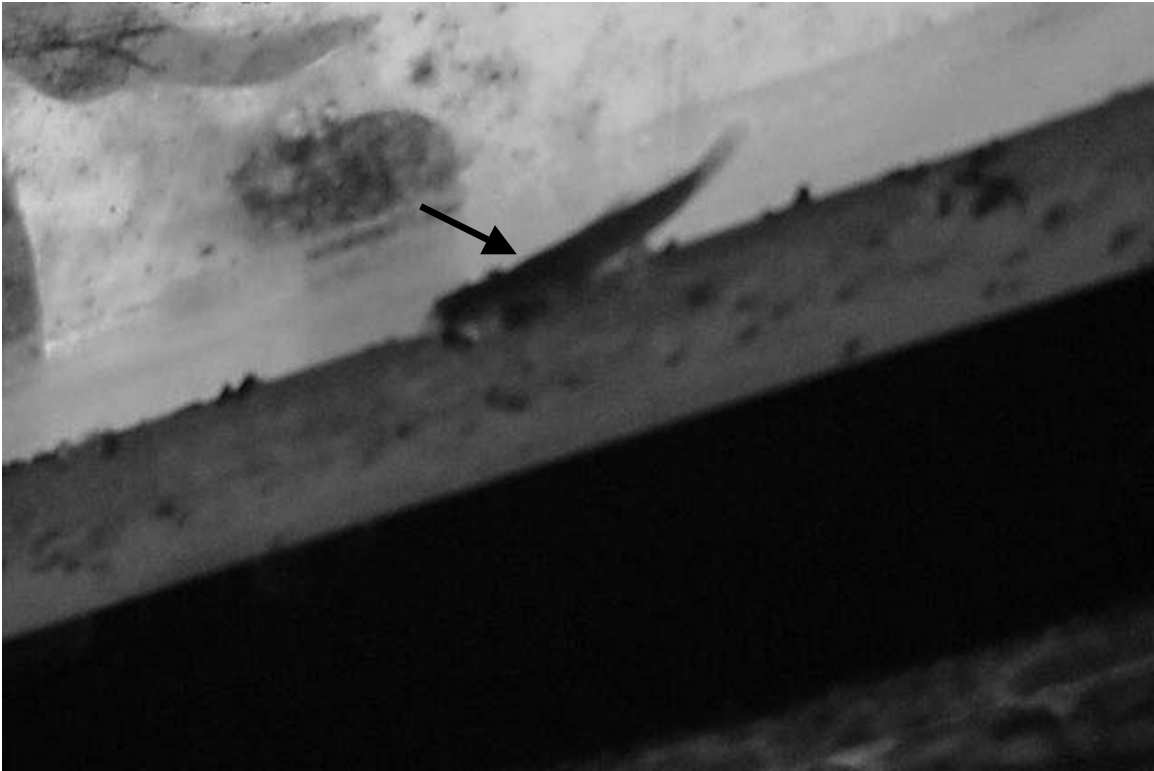
**Picture 9**

**Decaying fish in aquarium**

9. Consider having exterior brick re-pointed and waterproofed to prevent water intrusion.
10. Clean and maintain aquariums and terrariums to prevent bacterial/mold growth.  
Remove decaying fish from aquarium in classroom 20.

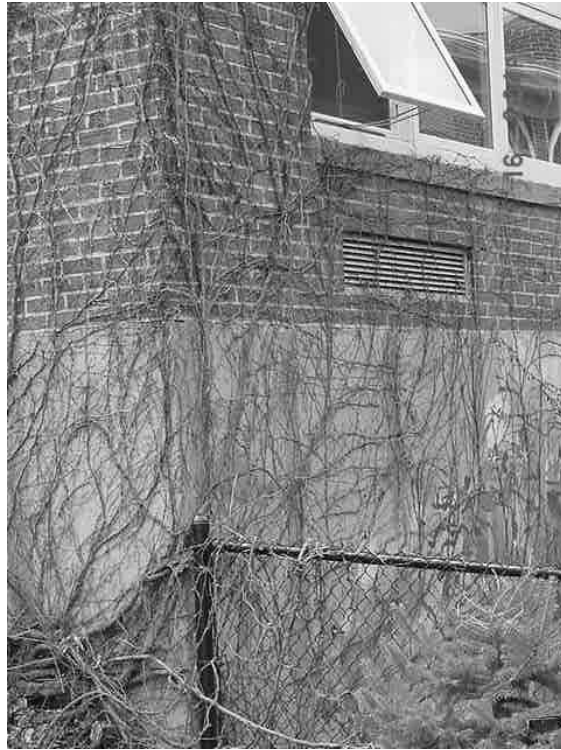
**Picture 10**

- One wall in the school courtyard has substantial clinging plant growth (Picture 10). Clinging plants can cause water damage to brickwork through the insertion of tendrils into brick and mortar. Water can penetrate into the brick along the tendrils, which can subsequently freeze and thaw during the winter. This freezing/thawing action can weaken bricks and mortar, resulting in damage to this wall. In order to avoid this problem, clinging plants on brickwork is not recommended.
- Shrubby and other plants exist in close proximity to the foundation walls (Picture 11). The growth of roots against the exterior walls can bring moisture in contact with wall brick and eventually lead to cracks and/or fissures in the foundation below ground level. Over time, this process can undermine the integrity of the building

envelope and provide a means of water entry into the building through capillary action through foundation concrete and masonry (Lstiburek & Brennan, 2001).

**Clinging plant growth on building exterior**

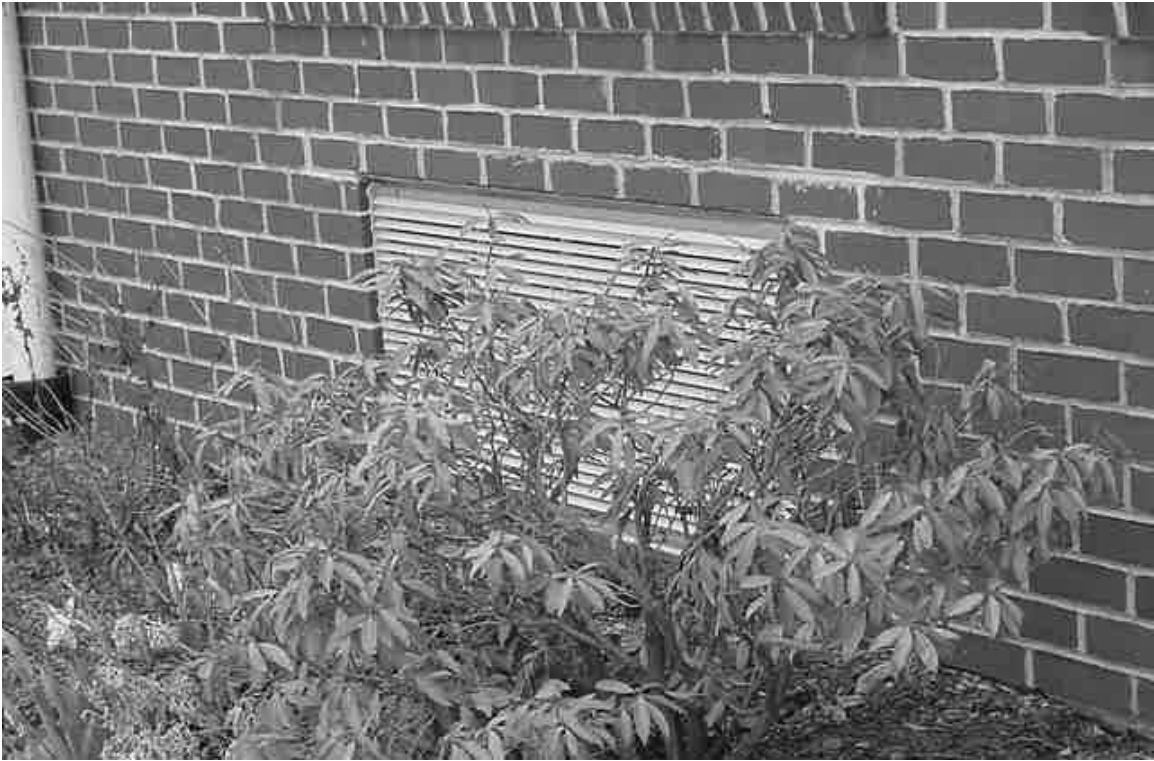
**Picture 11**

- Along the perimeter of the building, some of the univent fresh air intakes are located at ground level, near plant and soil (Pictures 11 and 12). Debris and plant matter were found in the intakes (Picture 13). Care should be taken to ensure that fresh air intakes remain clear of obstructions (e.g. snow, shrubbery) to avoid the entrainment of dirt, moisture and or pollen.

**Plant growth close to building. Shrubbery located in front of fresh air intake**

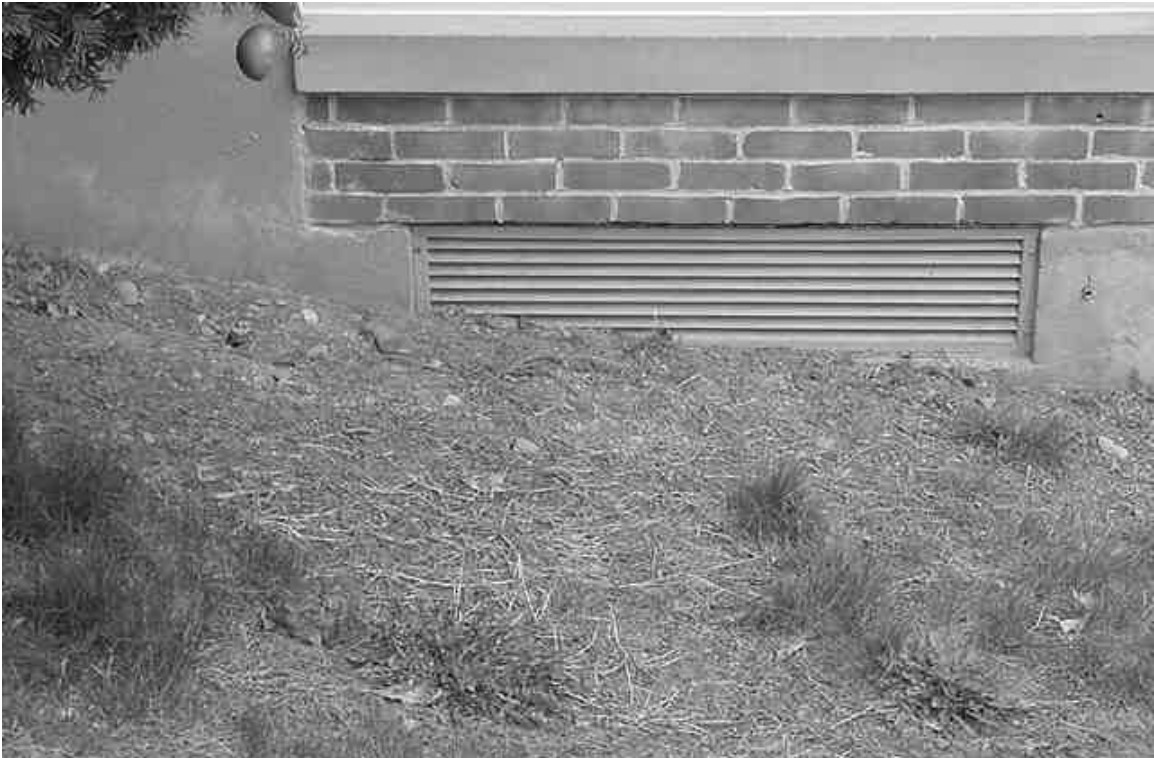
**Picture 12**

**Location of vent in relation to ground**

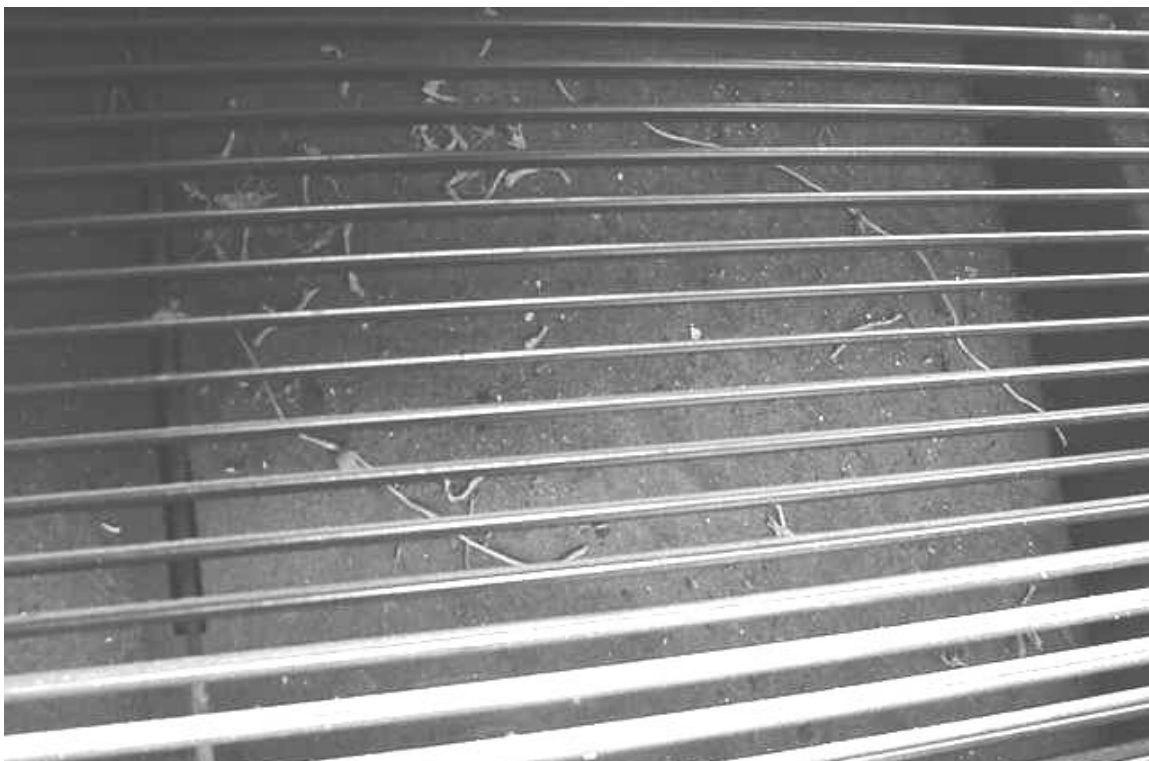
**Picture 13**

**Debris in vent**

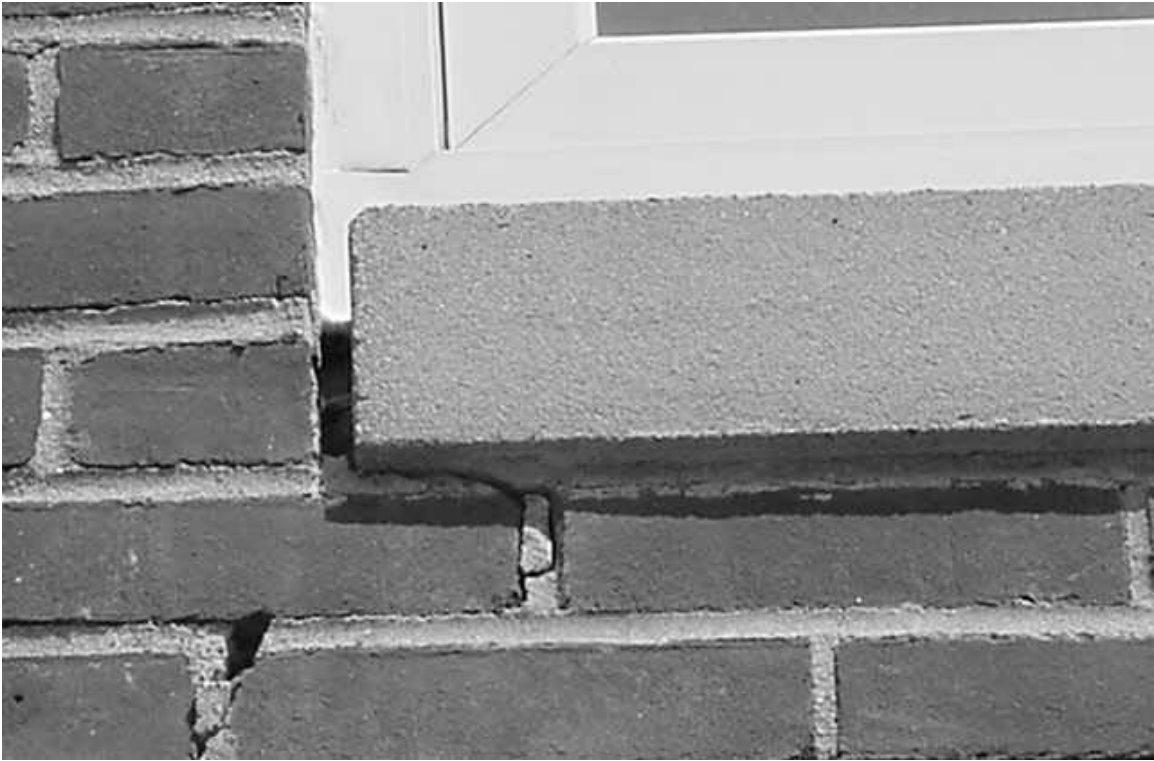
**Picture 14**

- The exterior walls had spaces/cracks in brickwork. In many areas mortar around exterior brickwork appears to be crumbling or missing (see Picture 14). Picture 15 shows open utility holes in exterior brickwork, which can serve as an entryway for pests. These conditions are breaches of the building envelope and provide a means for water entry into the building. Repeated water penetration can result in the chronic wetting of building materials and the potential for microbial growth. In addition large wall cracks may provide a means of egress for pests/rodents into the building.

**Damaged mortar and missing caulking**

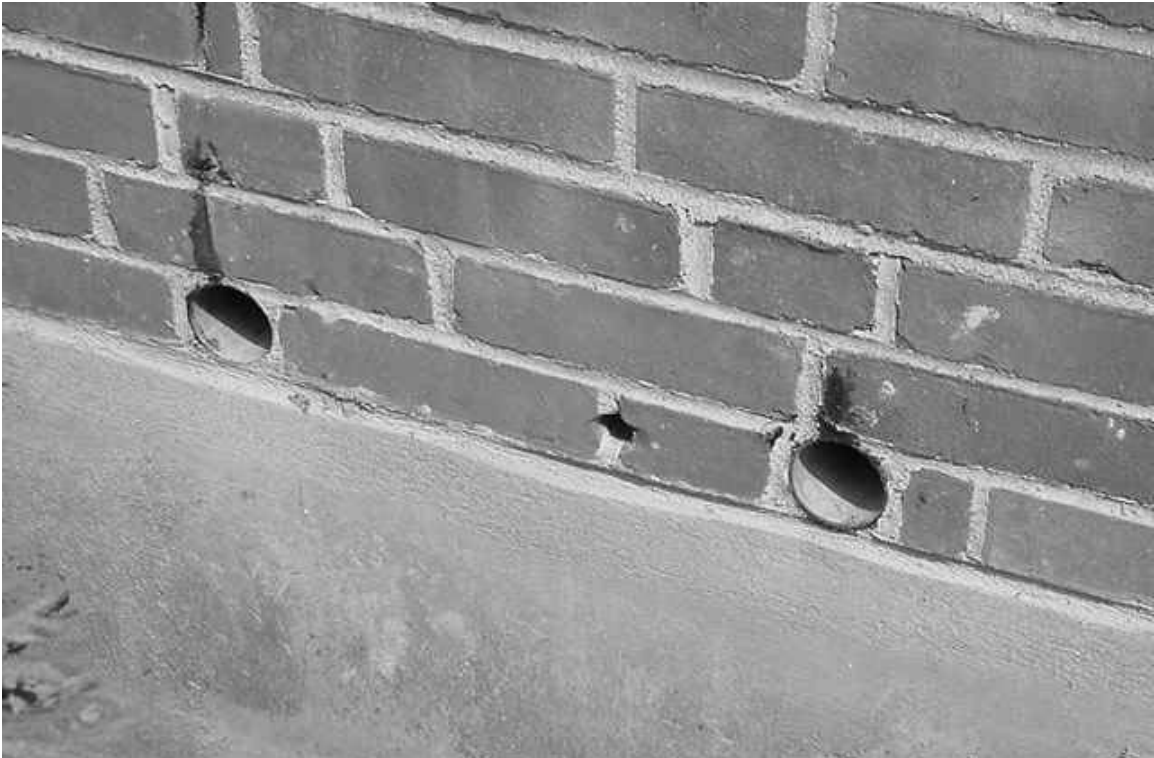
**Picture 15**

**Unsealed holes in exterior brickwork**

16. Seal all utility holes, wall cracks and any other possible pathways to prevent the egress of materials into the school.
17. Remove wasp's nests from perimeter of the building in a manner as to not introduce insects and/or pesticides into the building.

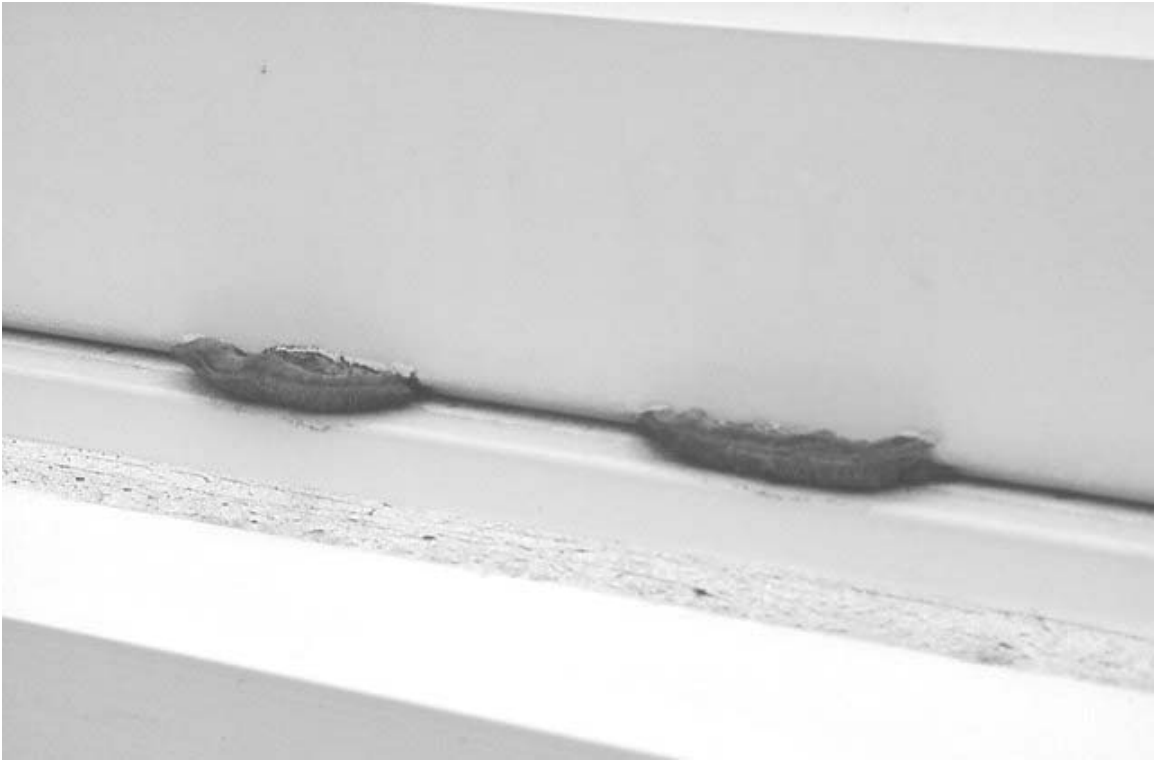
**Picture 16**

In one instance, microbial growth was observed to be growing on exterior window caulking (Picture 16). This material should be cleaned and disinfected with an appropriate antimicrobial agent and cleaned with soap and water.

**Fungal growth in windowsill**

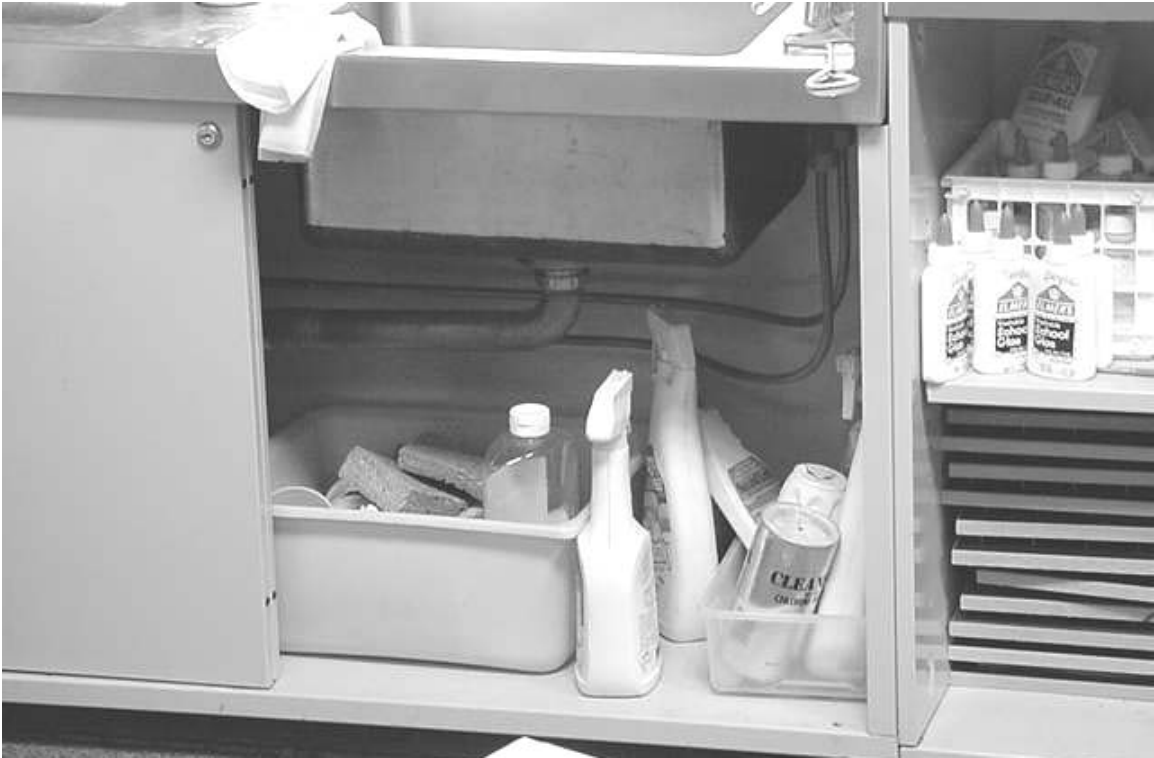
**Picture 17**

cabinets and on counter tops in several classrooms (Picture 17). Cleaning products contain chemicals (such as bleach or ammonia-related compounds), which can be irritating to the eyes, nose and throat. In some cases products found were labeled flammable or contained acetone, an organic solvent. These items should be stored properly and out of the reach of students.

**Cabinet drawer with spray cleaning agents**

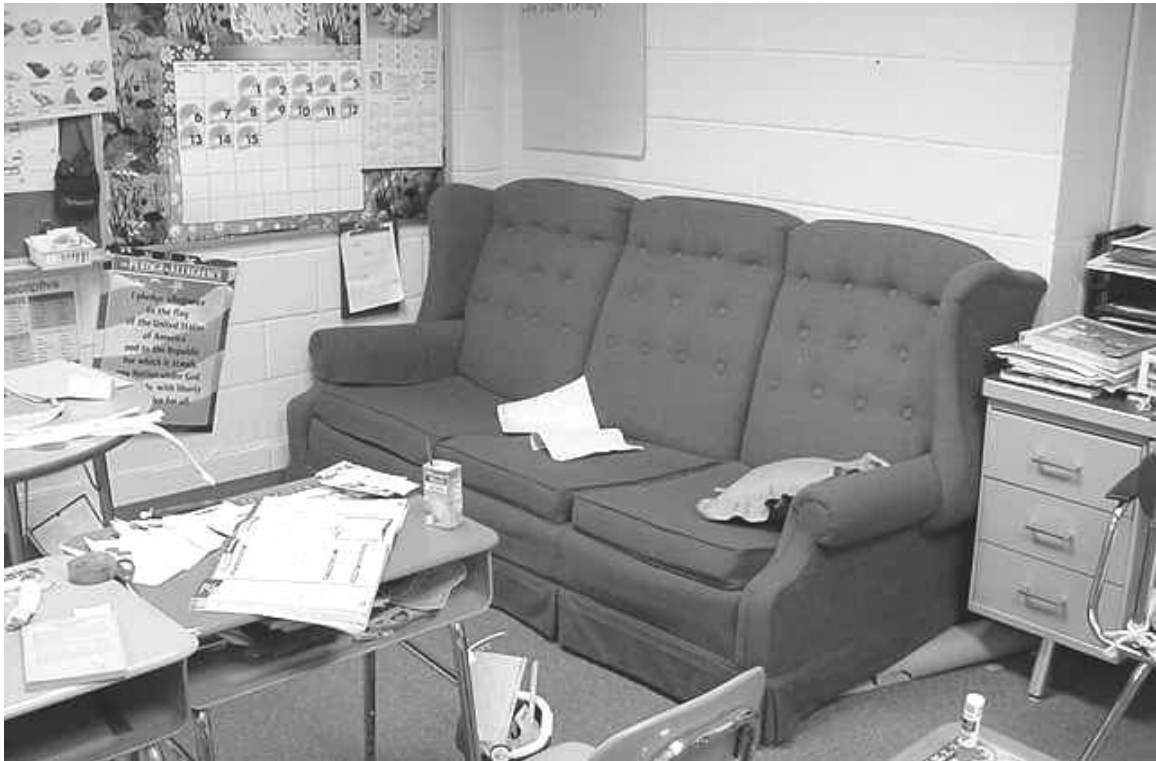
**Picture 18**

A number of classrooms contained upholstered furniture (Picture 18). Upholstered furniture is covered with fabric that comes in contact with human skin. This type of contact can leave oils, perspiration, hair and skin cells. Dust mites feed upon human skin cells and excrete waste products that contain allergens. In addition, if relative humidity levels increase above 60 percent, dust mites tend to proliferate (US EPA, 1992). In order to remove dust mites and other pollutants, frequent vacuuming of upholstered furniture is recommended (Berry, 1994). It is also recommended that upholstered furniture (if present in schools), be professionally cleaned on an annual basis or every six months if dusty conditions exist outdoors (IICR, 2000).

**Upholstered furniture**

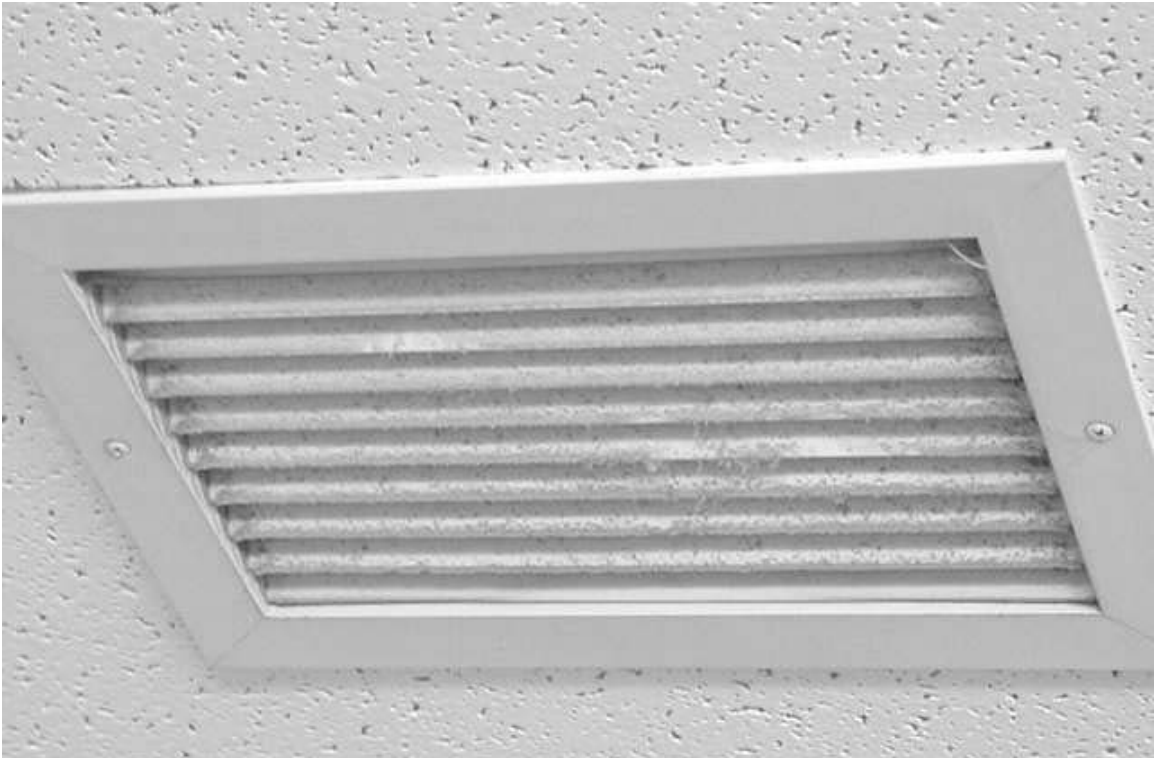
**Picture 19**

A number of exhaust vents in classrooms were noted with accumulated dust (Picture 19). If exhaust vents are not functioning, backdrafting can occur, which can re-aerosolize accumulated dust particles. Personal fans were also observed to have a thick layer of accumulated dust that can become re-aerosolized when the fan is in use (Picture 20).

**Accumulated dust on exhaust vent**

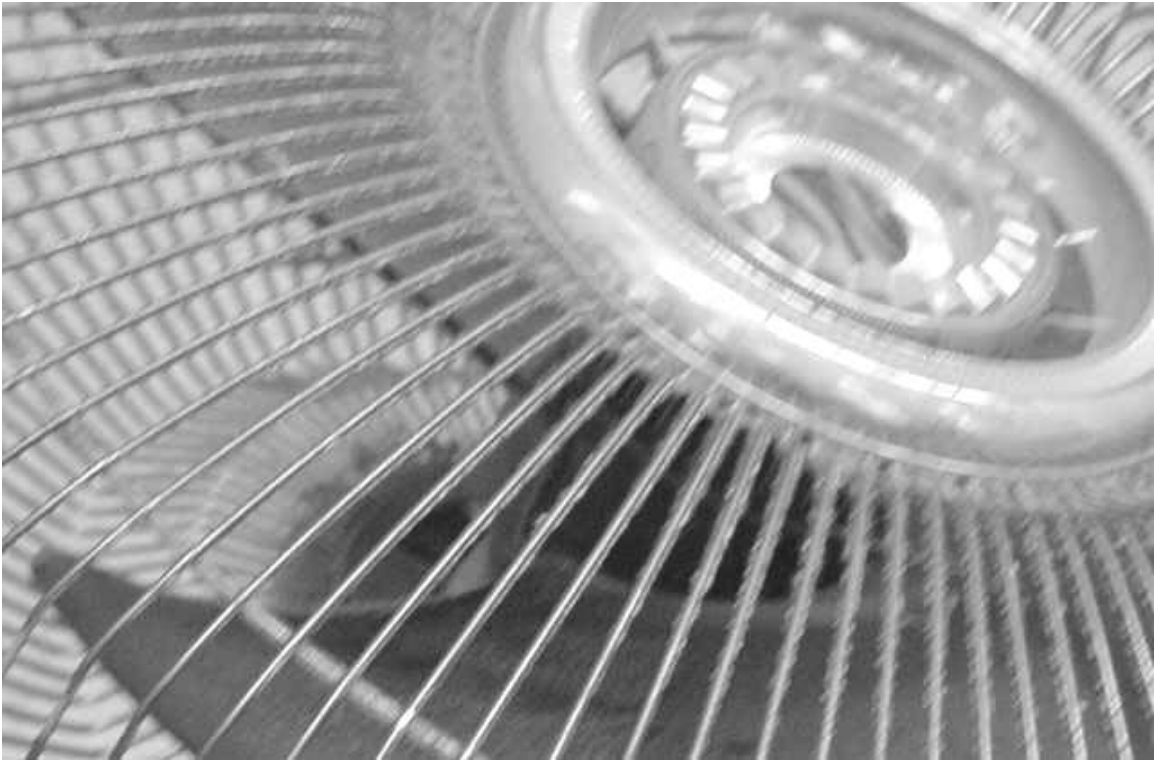
**Picture 20**

**Accumulated dust on personal fan**

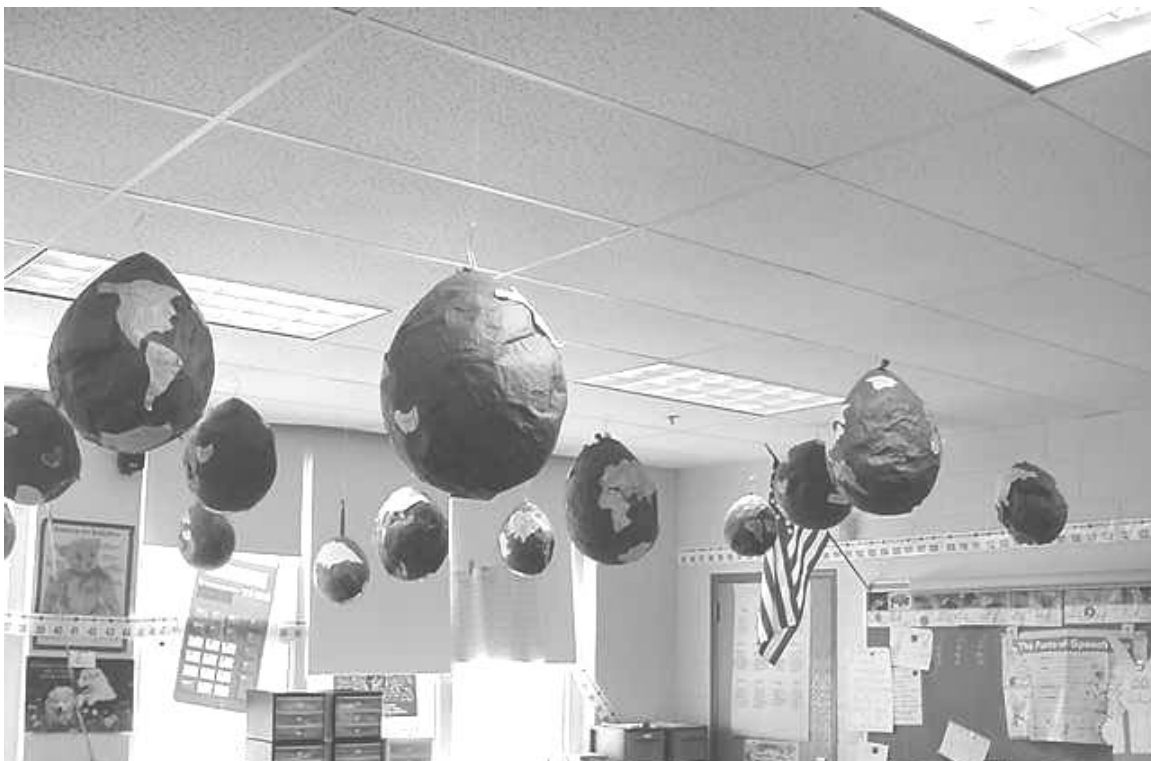
**Picture 21**

Items were observed hanging from ceiling tiles (Picture 21). The movement or damage to ceiling tiles can release accumulated dirt, dust and particulates that accumulate in the ceiling plenum into occupied areas. As previously discussed, dust can be irritating to the eyes, nose and respiratory tract. Building occupants should refrain from hanging objects from ceiling tile systems.

**Items hanging from ceiling**

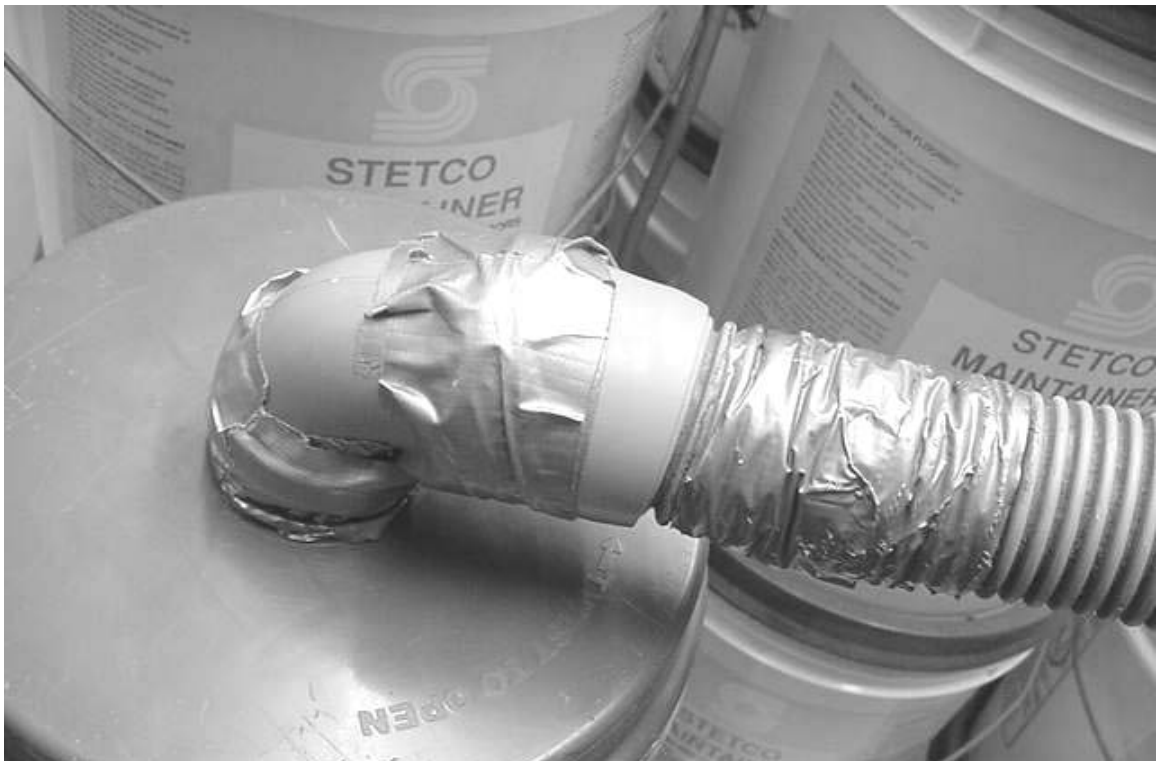
**Picture 22**

A vacuum cleaner was noted in the custodian's office with the vacuum hose secured by duct tape (see Picture 22). In this condition the hose can periodically loosen to provide the opportunity for the reaerosolization of dirt, dust and particulates into the environment.

**HEPA filtered vacuum held together by duct tape**

14. Consider replacing HEPA filtered vacuum, or obtain proper replacement parts to allow for proper function of equipment.
15. Clean chalkboards and trays regularly to avoid the build-up of excessive chalk dust.

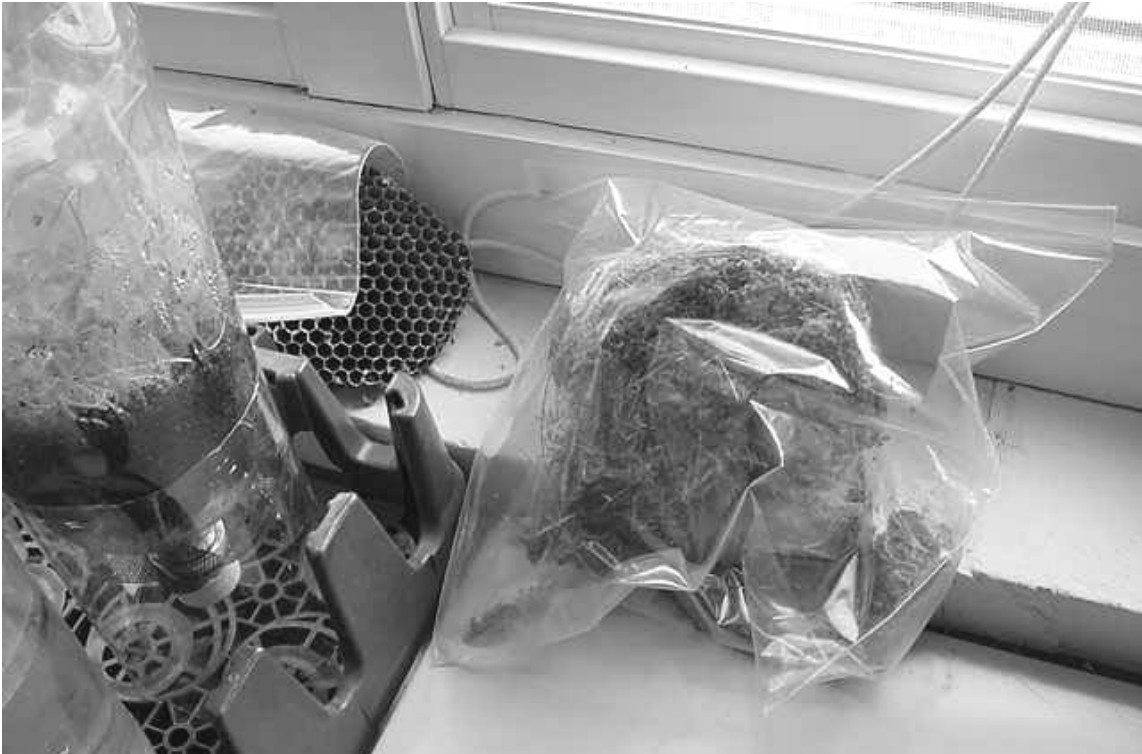
**Picture 23**

Inactive wasps' and birds' nests were noted in classrooms and reportedly serve as learning props. Insect parts can become dried out and aerosolized and may serve as a source of allergenic material for certain sensitive individuals. Bird's nests can contain bacteria and may also be a source of allergenic material. Nests should be stored in re-sealable plastic bags to prevent aerosolization of allergenic materials (Picture 23). These

**Sealed and unsealed nests on window sill/univent**

items should also be located away from univents to prevent the aerosolization of insect parts and/or allergenic material.

18. Store nests used for educational purposes in sealed containers and away from ventilation units.
19. In order to maintain a good indoor air quality environment on the building, consideration should be give to adopting the US EPA document, "Tools for Schools". This document can be downloaded from the Internet at <http://www.epa.gov/iaq/schools/index.html>.
